PHASE I INSPECTION REPORT  
NATIONAL DAM INSPECTION PROGRAM

PHASE I INSPECTION REPORT,  
NATIONAL DAM INSPECTION PROGRAM

Based on a review of available design information and visual observations of conditions as they existed on the date of the field inspection and engineering analyses performed, the general condition of Lakewood Dam is considered to be poor.

# LAKewood DAM

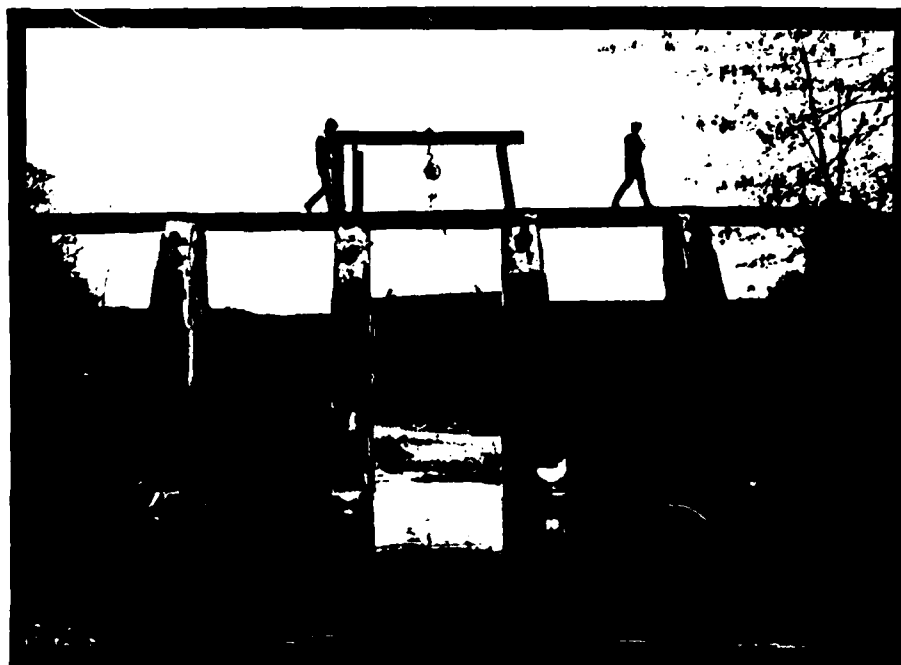
(2) Overflow Section: The principal spillway overflow section (weir) was observed to be in very poor condition with considerable spalling and disintegration of concrete surfaces. Reinforcing steel was exposed, rusted and corroded to only a fraction of its original diameter. The upstream face and base of the weir wall were observed to be somewhat spalled and eroded, particularly in the vicinity of the outlet works opening.

(3) Structural Conditions: The formed concrete training walls were observed to be significantly disintegrated, spalled and contained exposed reinforcing bars that have been rusted and corroded to a fraction of their original diameter.

The reinforced concrete counterfort piers were observed to be in a similar state of disintegration. Spalling and disintegration of face and side surfaces is extensive. Considerable reinforcing steel is exposed and generally corroded and rusted away. Particularly significant erosion of the concrete has occurred at and just above the waterline where a significant portion of the counterfort piers have been eroded.

Photo 8 Principal Spillway structure showing low level outlet works as seen from downstream.
